# Horncastle Reservoir Low-Level Outlet Sluice Gate

## Asset Performance Review

Feb 2024

# **Horncastle Reservoir Asset Performance Review**

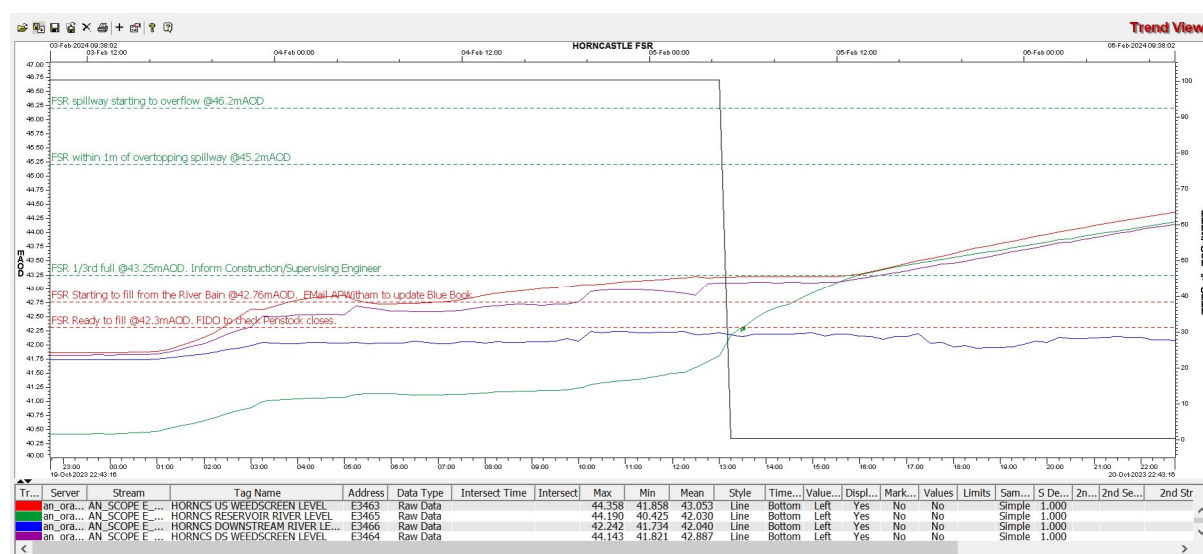
**Figure 7 – Trend plot from SWANTEL showing the action levels for Horncastle FSR.**

The need for action included in the detail of the warning is somewhat hidden by the "information" status of the alarm title. However, if the FIDO had read the detail of the alarm it is assumed that this would have triggered the actions required. The trend plot shown below, does include the action to check that the sluice gate is closed, with an indication on the trend that the sluice gate is not closed.

However, the 'for information' status of the alarm would naturally curtail the duty officer's desire to interrogate the further detail when an incident is busy and multiple alarms are being received.

**Note:** This trend also shows the gate closure (black line) and filling of the reservoir (green line)

**RECOMMENDATION 4: Review the alarm handling to consider the wording and importance of existing alarms, and consider modifying or creating a new alarm to only require action when something has failed, rather than requiring an action for all operations.**

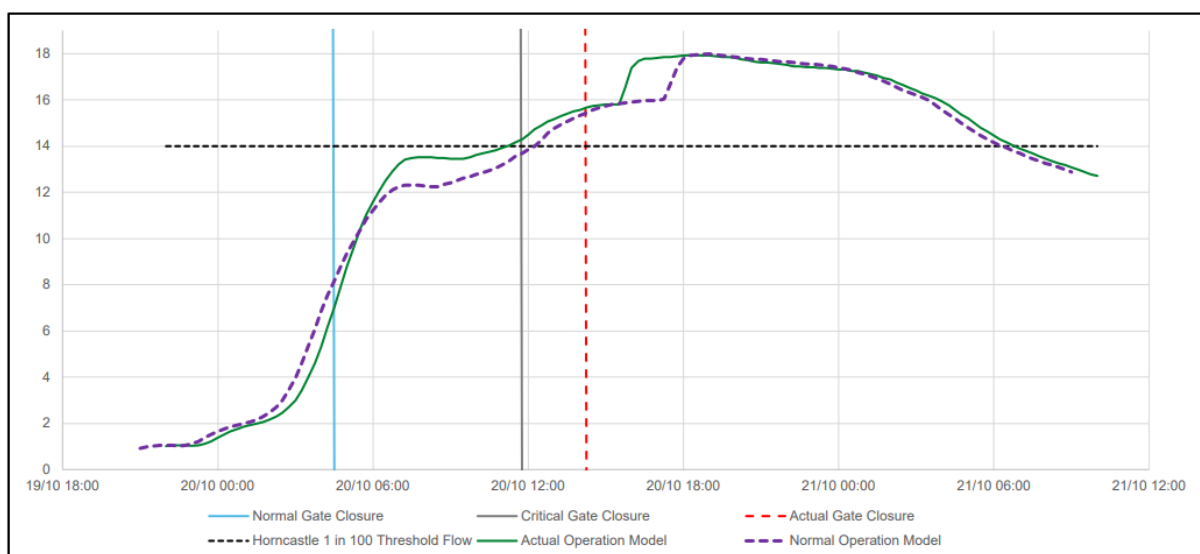
**Figure 8 – Modelled River Level trends in Horncastle with and without sluice gate closure.**

The *Horncastle Asset Operation Failure Impact Assessment* report has undertaken hydrological and hydraulic modelling of the catchment during Storm Babet. This modelling has looked at the response and impact in the catchment with the sluice gate operating normally, and with the delay to the sluice gate closure allowing additional flow downstream. *Figure 8* below shows the outputs from the model runs for Victoria Mill (Horncastle). The open sluice gate appears to have allowed river levels to rise sooner in Horncastle but did not cause a greater peak flow in the town, and therefore did not contribute to the flooding of properties. The flooding in Horncastle is due to the very significant flood event occurring on the uncontrolled tributaries downstream of the dam, which caused a flood peak some 4 hours after the sluice gate at the dam was closed.

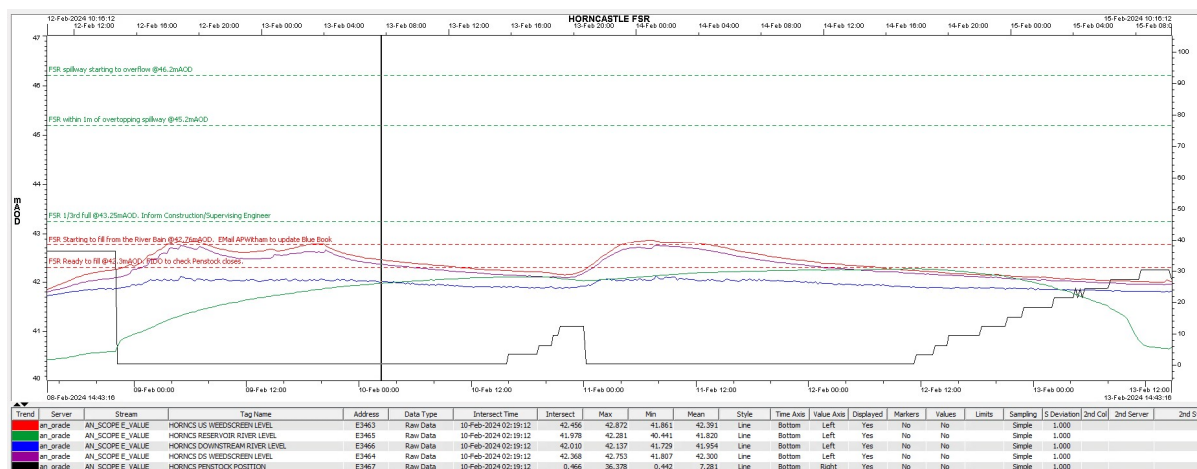
**Figure 9 – Trend view of a recent flood event at Horncastle FSR**

Since these improvements have been implemented, the performance of the penstock has been much improved. For the period 18<sup>th</sup> November 2023 to 15<sup>th</sup> February 2024, the penstock has closed automatically on all eight occasions that it was required to do so. The Swantel trend view for the event on 8<sup>th</sup> February 2024 is shown in Figure 9 below.

The trend view in Figure 9 shows the sluice gate (black line) held at around 35% open, and then closing automatically when the closure threshold of the river (red line) is met. The reservoir level (green line) then increases until the river level falls below the threshold and the gate starts to open and the reservoir level starts to fall. The gate closes again as the river level increases, increasing the levels in the reservoir, until the river level drops and the sluice gate returns to its partly open position.

6. The time-period between gate movements has been extended from 5 mins to 15 minutes resulting in considerably less modulation of the sluice gate.

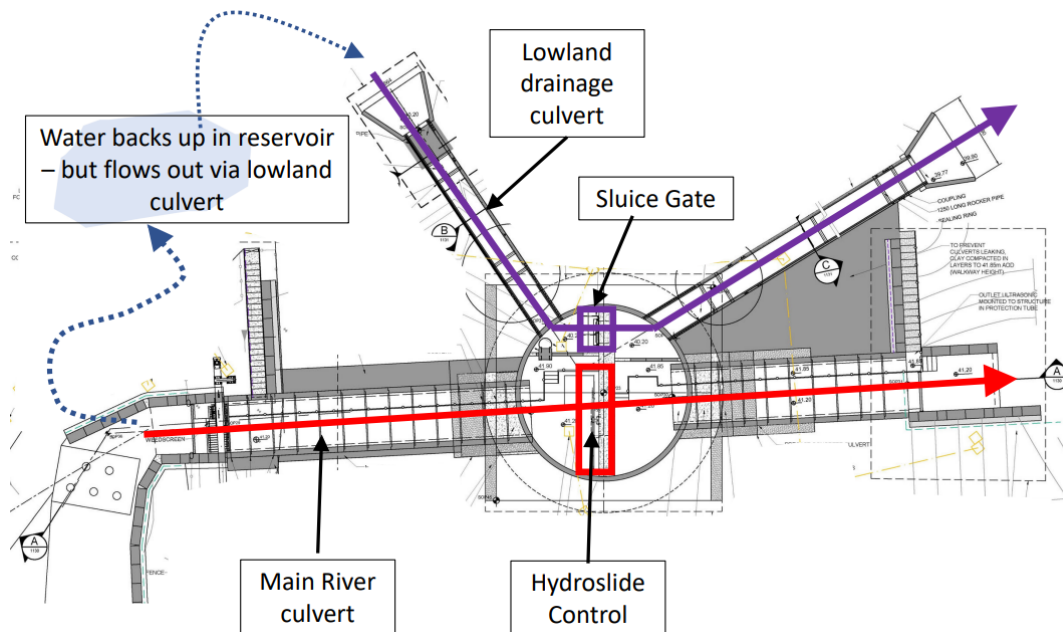
- 1) The normal river flow passing under the dam is shown by the red line.
- 2) In the central chamber the Hydroslide (red rectangle) remains open for normal flow.

- 9) When flow reaches  $7.1\text{m}^3/\text{s}$ , the Hydroslide comes into operation to limit flows, and the reservoir impounds all flow above  $7.1\text{m}^3/\text{s}$ .

- 10) During Storm Babet, the low-level sluice gate was open, and flood flow passed through the low-level culvert instead of being retained.

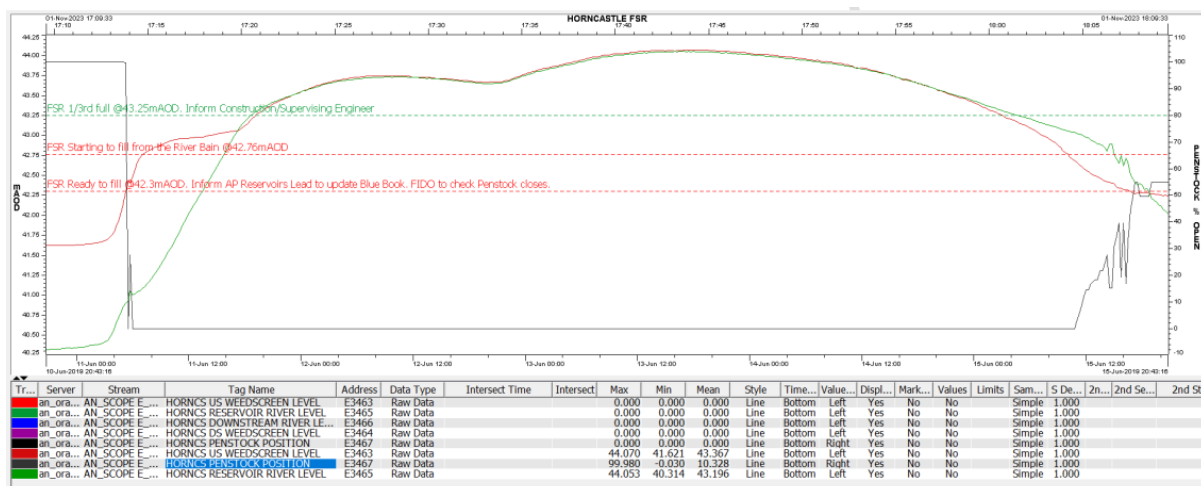
### 1) 11<sup>th</sup> June 2019 – Successful Closure

The River Level (red line) at the Weedscreen passes the threshold for gate closure. The gate opening trend (black line) quickly moves from 100% (fully open) to 0% (fully closed). The reservoir (green line) starts to fill immediately. Reservoir levels increase rapidly to meet and drown-out the perched river level. As river levels return to the threshold, the gate (black line) starts to open. This was a significant storage event. Note the gate closure trend intersecting the river level trend at the point the river level reaches the gate closure trigger.

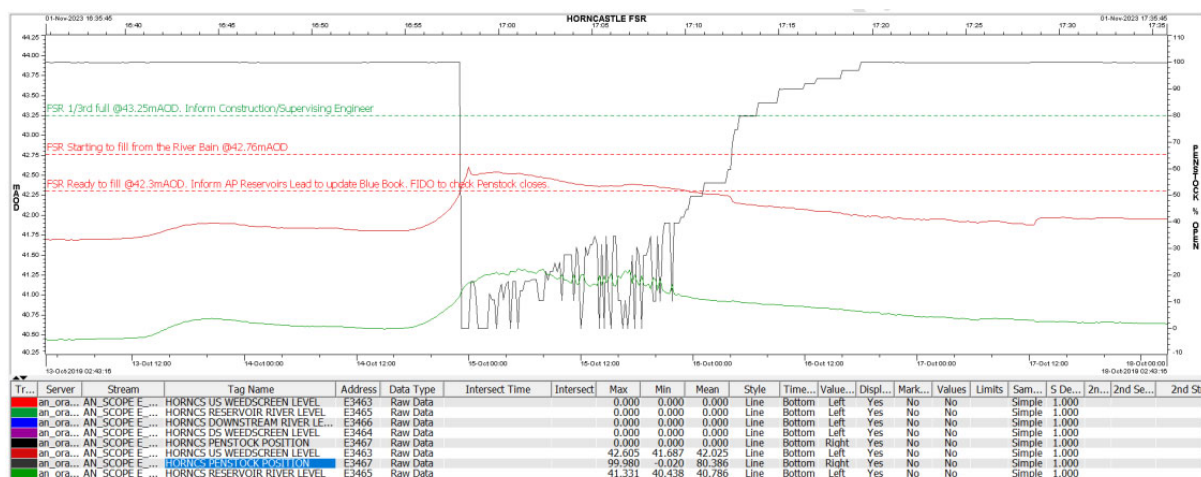
### 2) 15<sup>th</sup> October 2019 – Successful Closure but significant modulation

The River Level (red line) at the Weed-screen passes the threshold for gate closure. The gate opening trend (black line) quickly moves from 100% (fully open) to 0% (fully closed). The reservoir (green line) starts to fill. Not long after closure, with river levels still above the threshold, the sluice gate starts to modulate with frequent openings up to 20% and then 30% open. This results in the reservoir not filling effectively as the retained water is constantly released with the gate openings. The modulation of the gate was a regular feature up to November 2019 when the gate automation stopped working, or was turned off, and the subsequent closures occurred manually.

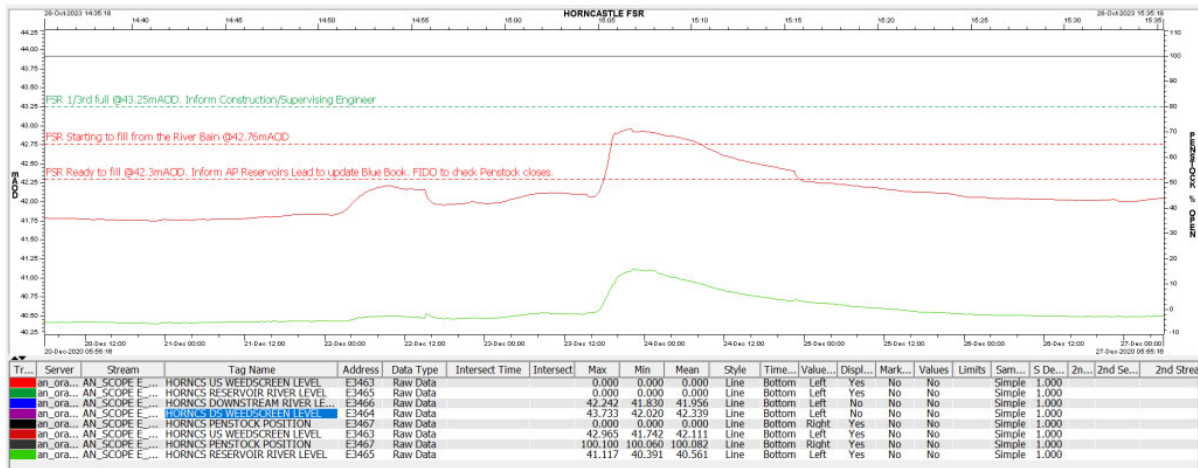
### 3) 23<sup>rd</sup> December 2020 – No Closure

The River Level (red line) at the Weedscreen passes the threshold for gate closure. The gate opening trend (black line) stays horizontal at 100% (fully open) – i.e. the sluice gate does not close. The river level passes through the threshold for reservoir filling for a significant period of time, but the reservoir level (green line) shows minimal response to the ‘filling’ because the sluice gate is in the open position. The river is above the sluice gate closure level for 29.5 hours while the reservoir was above the ‘filling’ level for 15 hours.
