## Section 19

Flood and Water Management  
Act 2010

Ref S19-729

Date and version number –  
05/12/2024

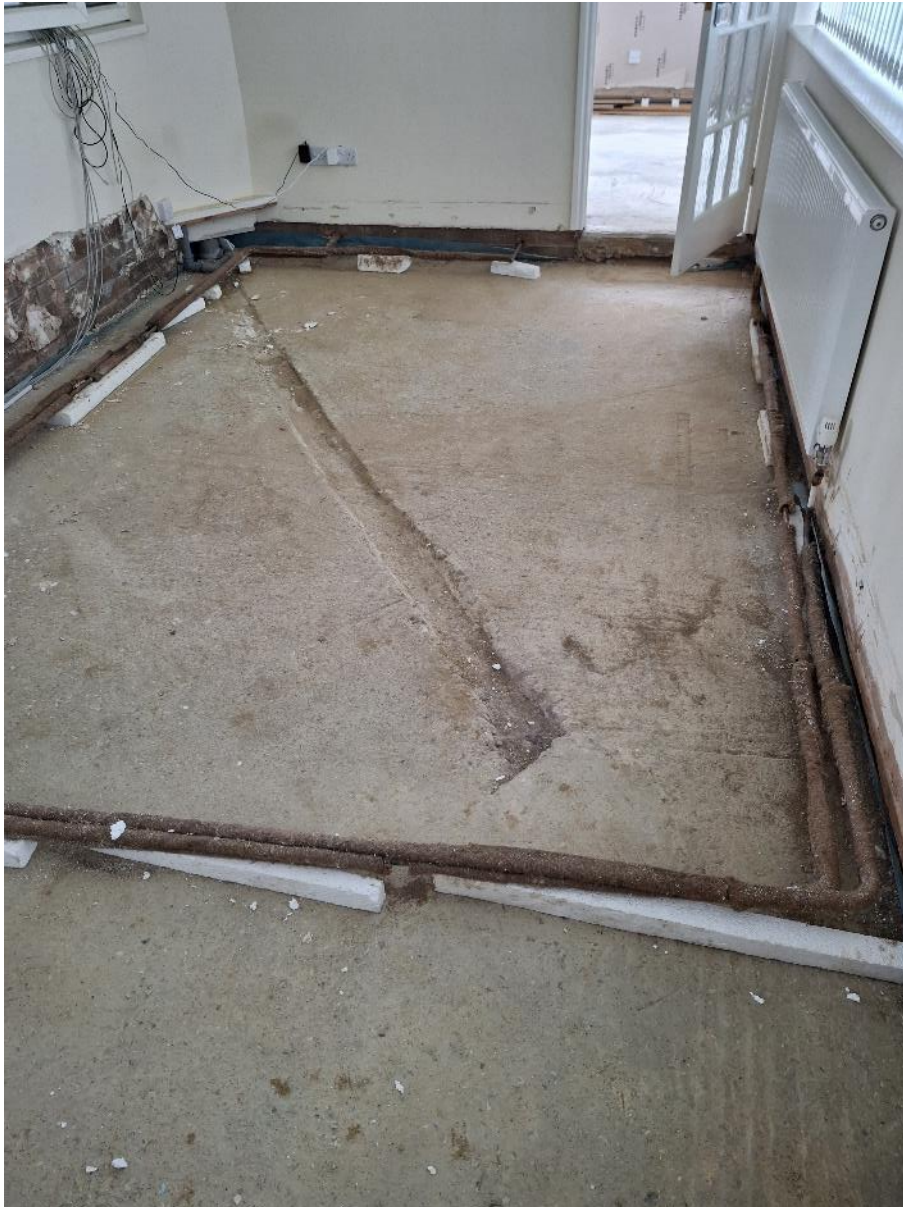
(Photograph 12.2 – Damages at [REDACTED])

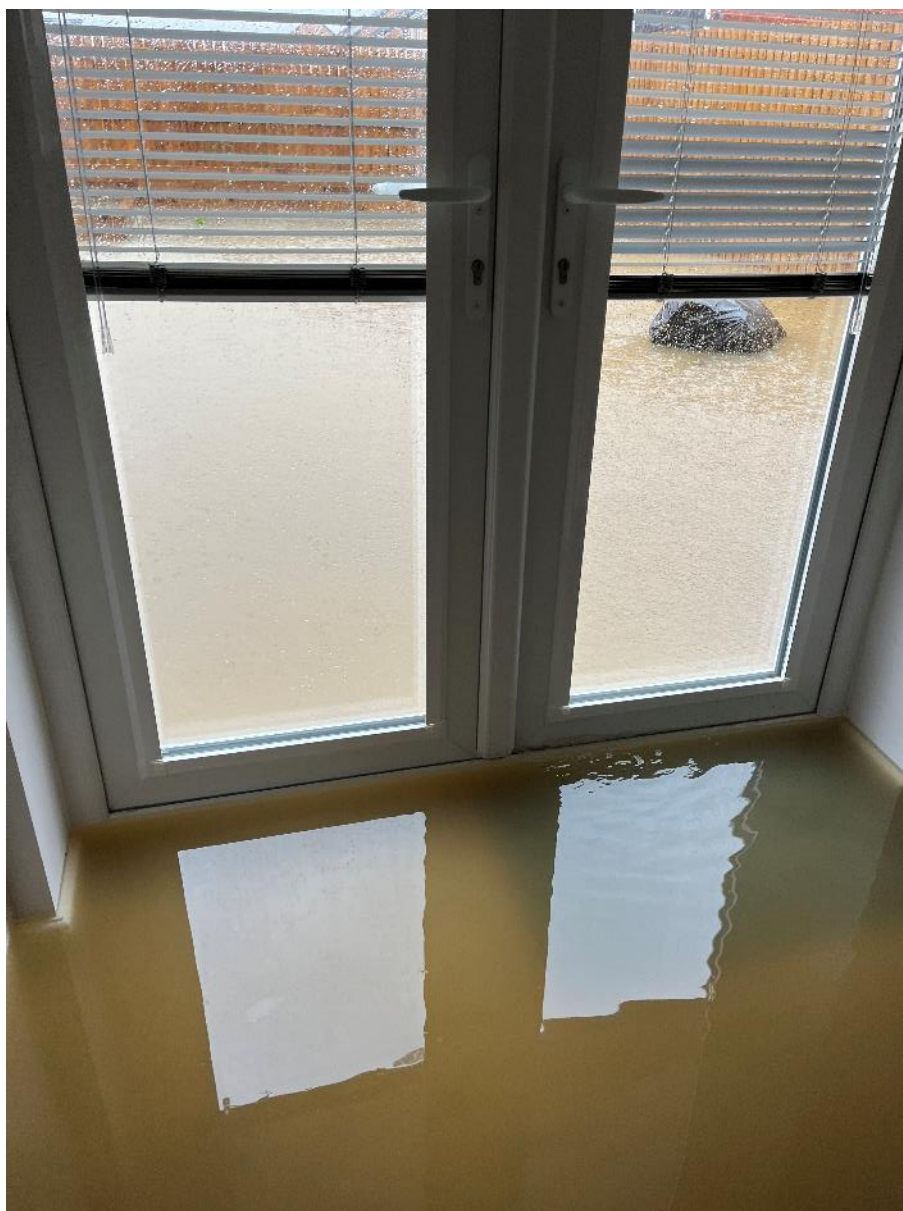
*(Photograph 1.6 – Internal flooding at [REDACTED])*

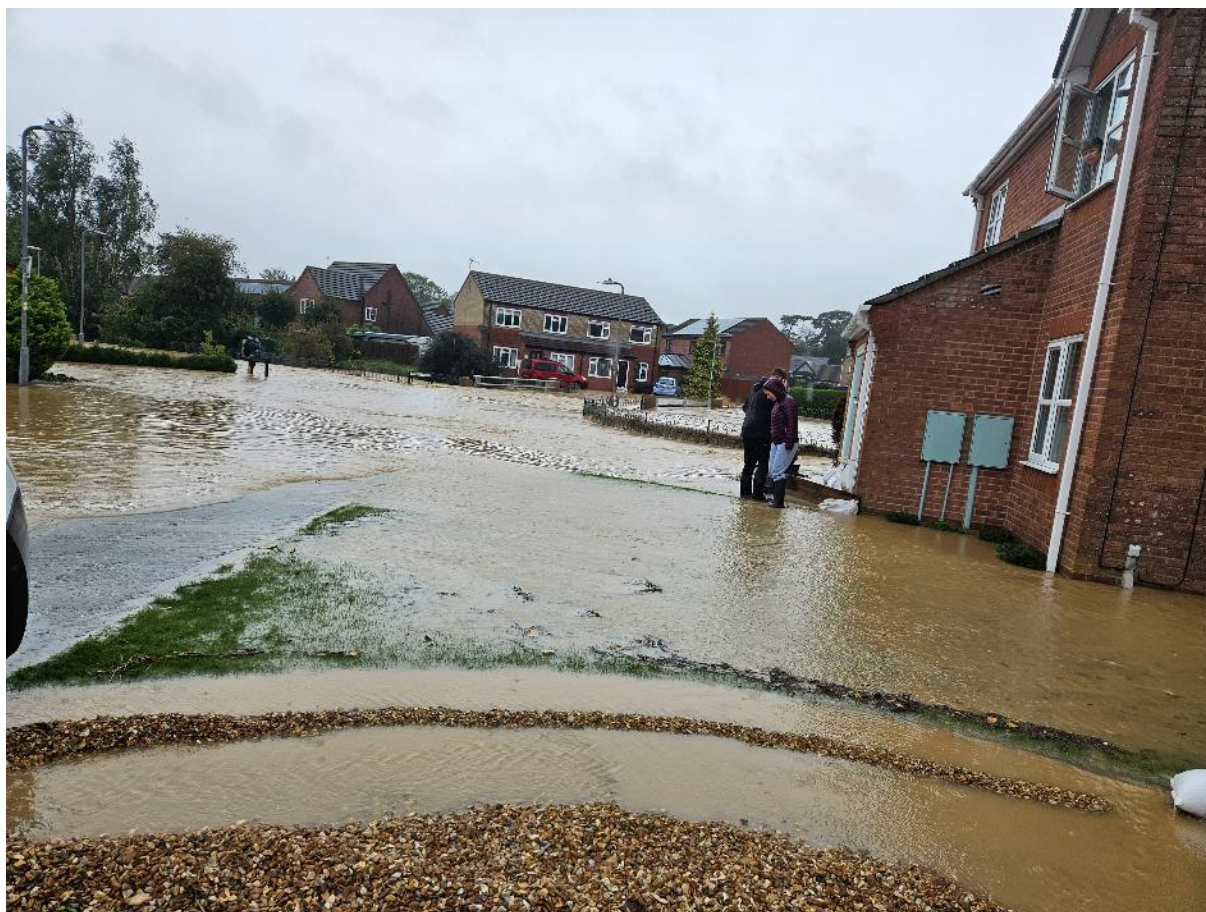
(Photograph 2.14 – Flood waters on Banovallum Gardens, as provided by the resident [REDACTED]; facing north)

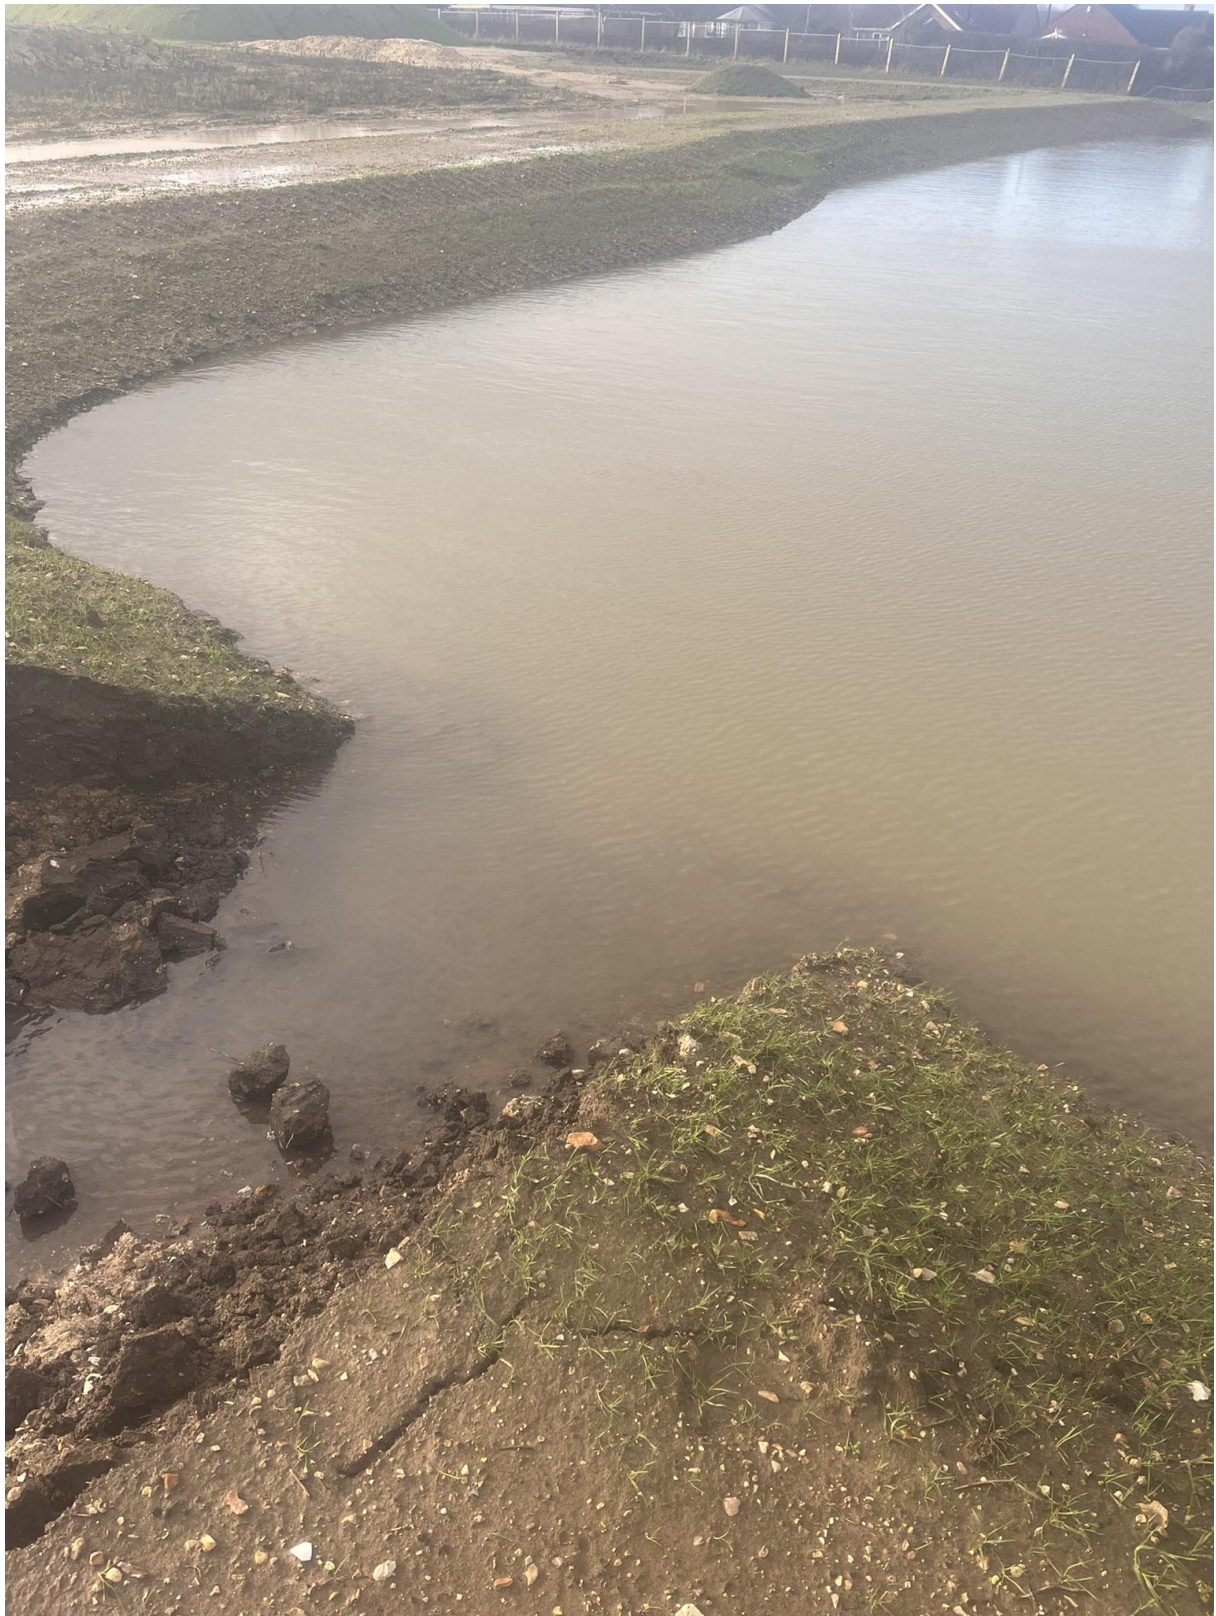
*(Photograph 2.20 – Breach on Poppy Fields on-site attenuation pond)*

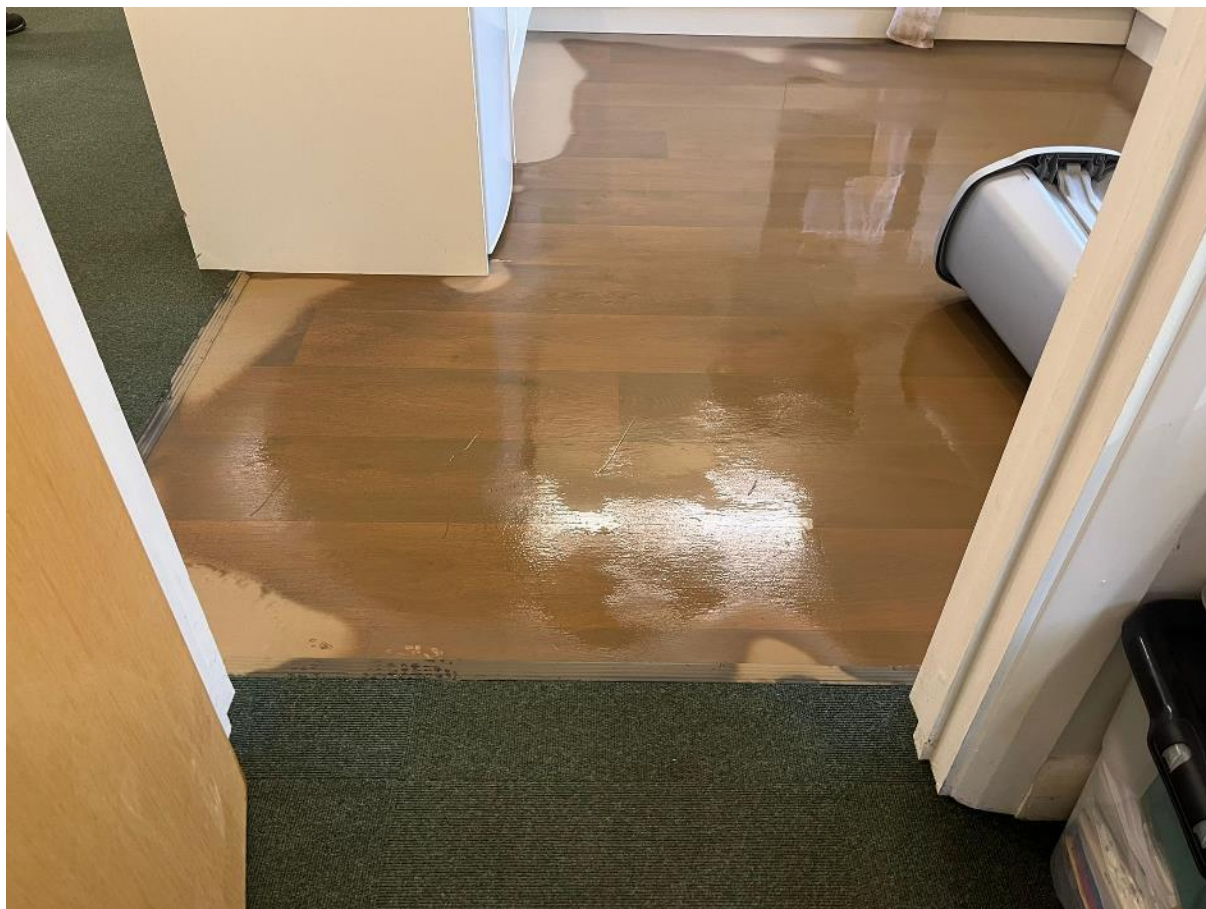
*(Photograph 3.12 – Water inside [REDACTED] following Storm Babet.)*

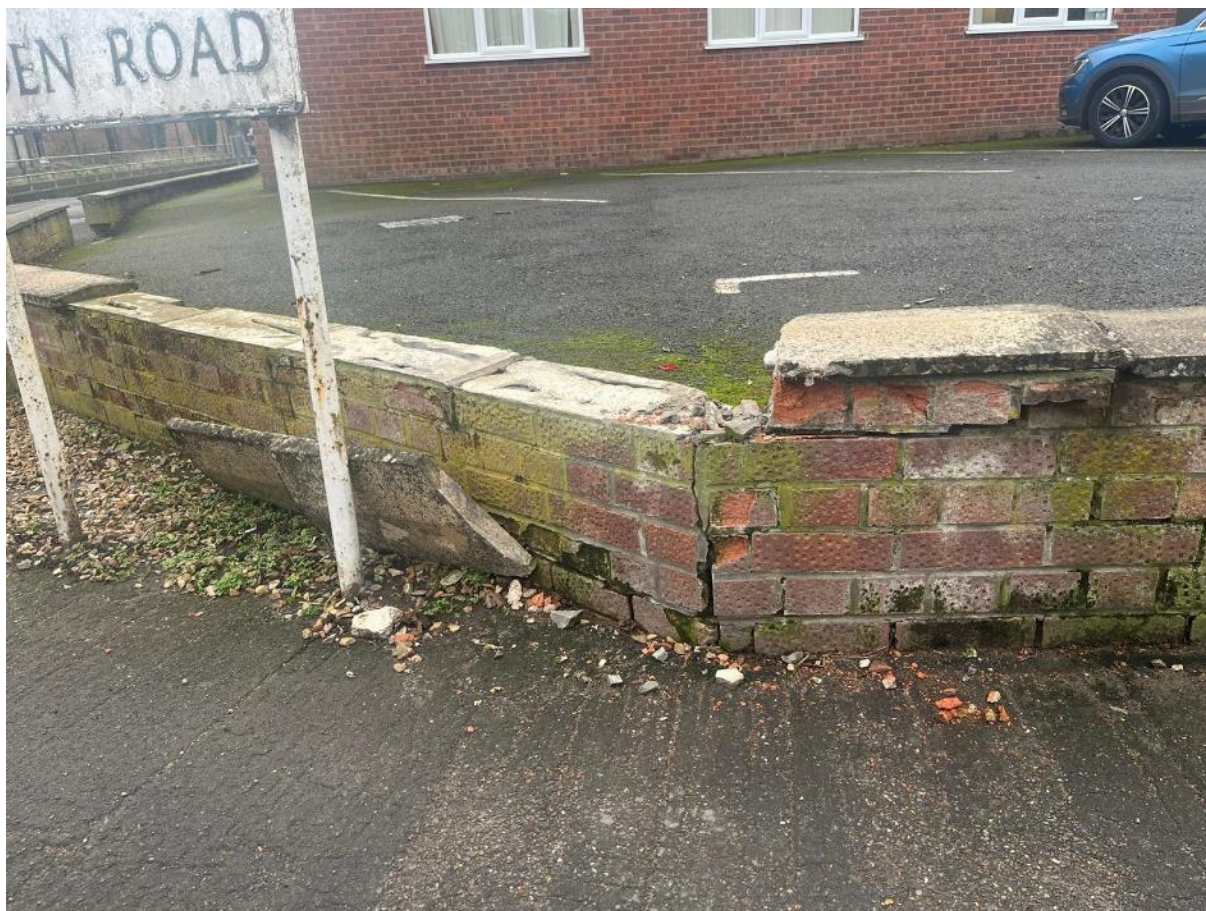
*(Photograph 3.13– Broken wall caused by fluvial flows during Storm Babet, as provided by the manager at the [REDACTED] on Banks Street)*
