# Horncastle Reservoir Low-Level Outlet Sluice Gate

## Asset Performance Review

Feb 2024

# **Horncastle Reservoir Asset Performance Review**

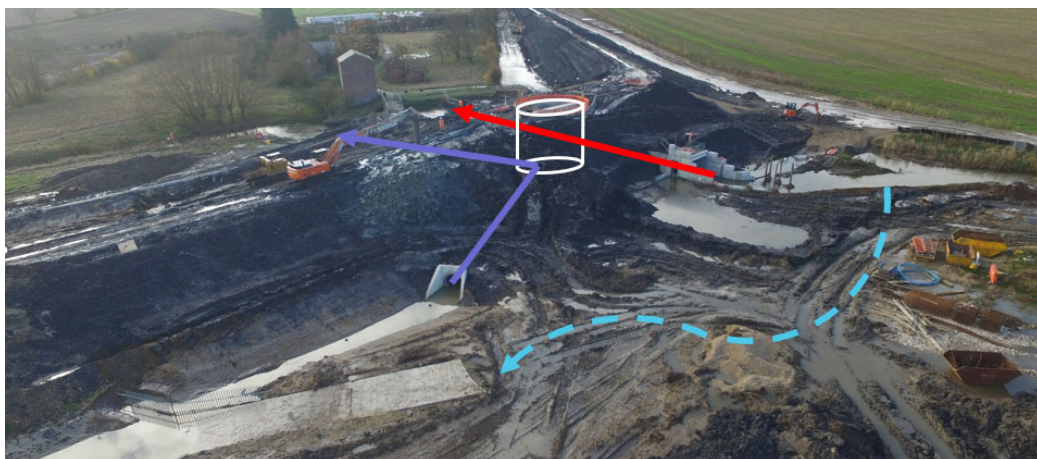
- 9) When flow reaches  $7.1\text{m}^3/\text{s}$ , the Hydroslide comes into operation to limit flows, and the reservoir impounds all flow above  $7.1\text{m}^3/\text{s}$ .

- 10) During Storm Babet, the low-level sluice gate was open, and flood flow passed through the low-level culvert instead of being retained.
