## Section 19

Flood and Water Management  
Act 2010

Ref S19-729

Date and version number –  
05/12/2024

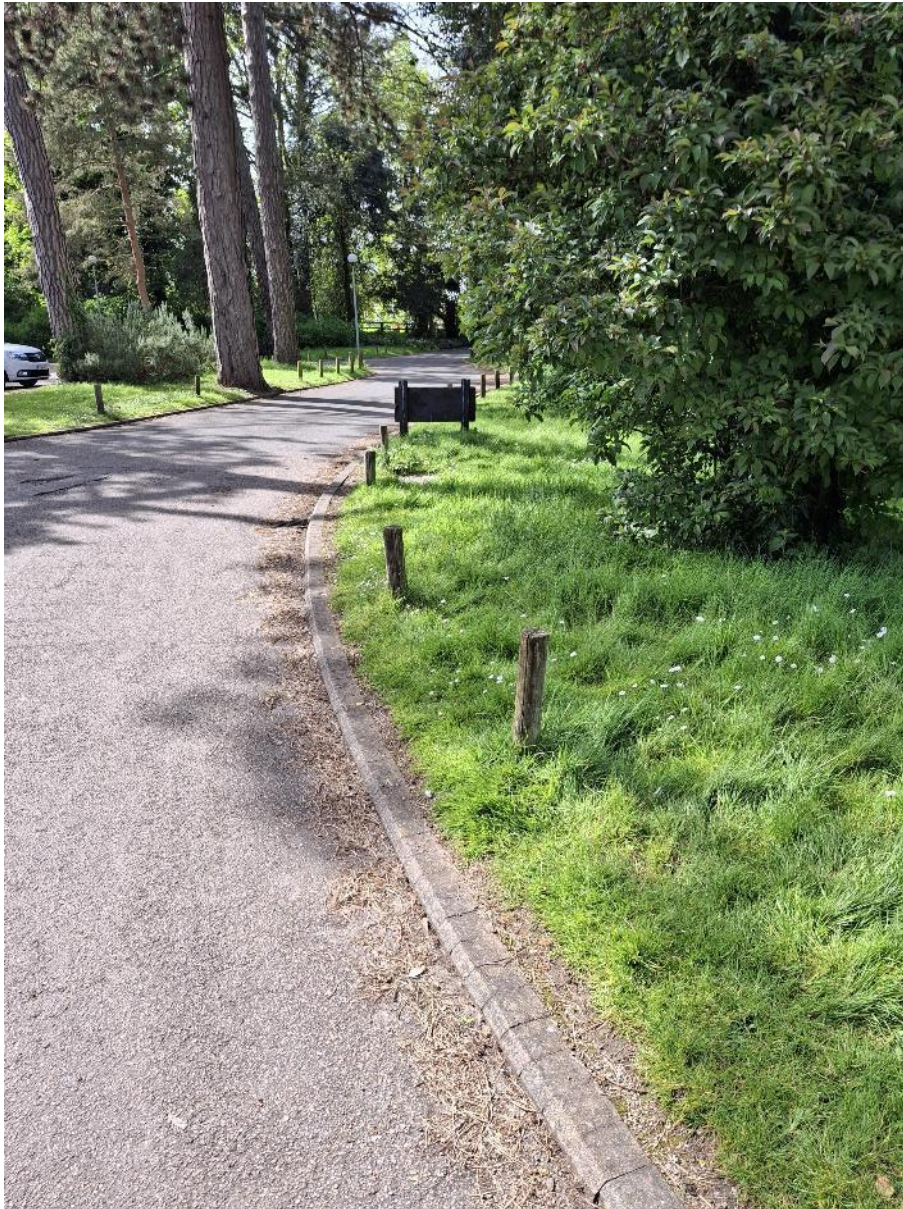
*(Photograph 2.13 – Blocked gully on the entrance road to [REDACTED])*

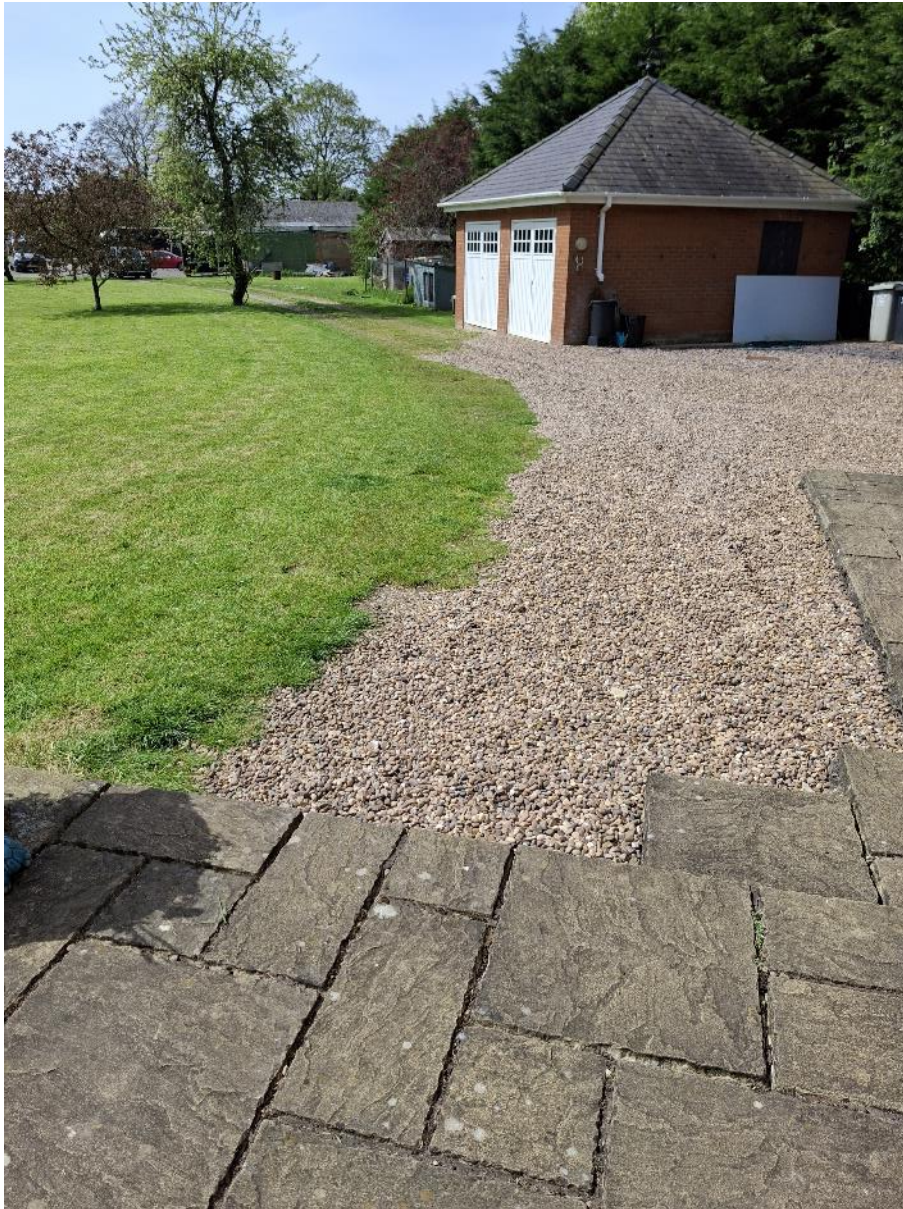
*(Photograph 3.4 – Residential garages at [REDACTED]. Flood waters came up to the property; facing west)*

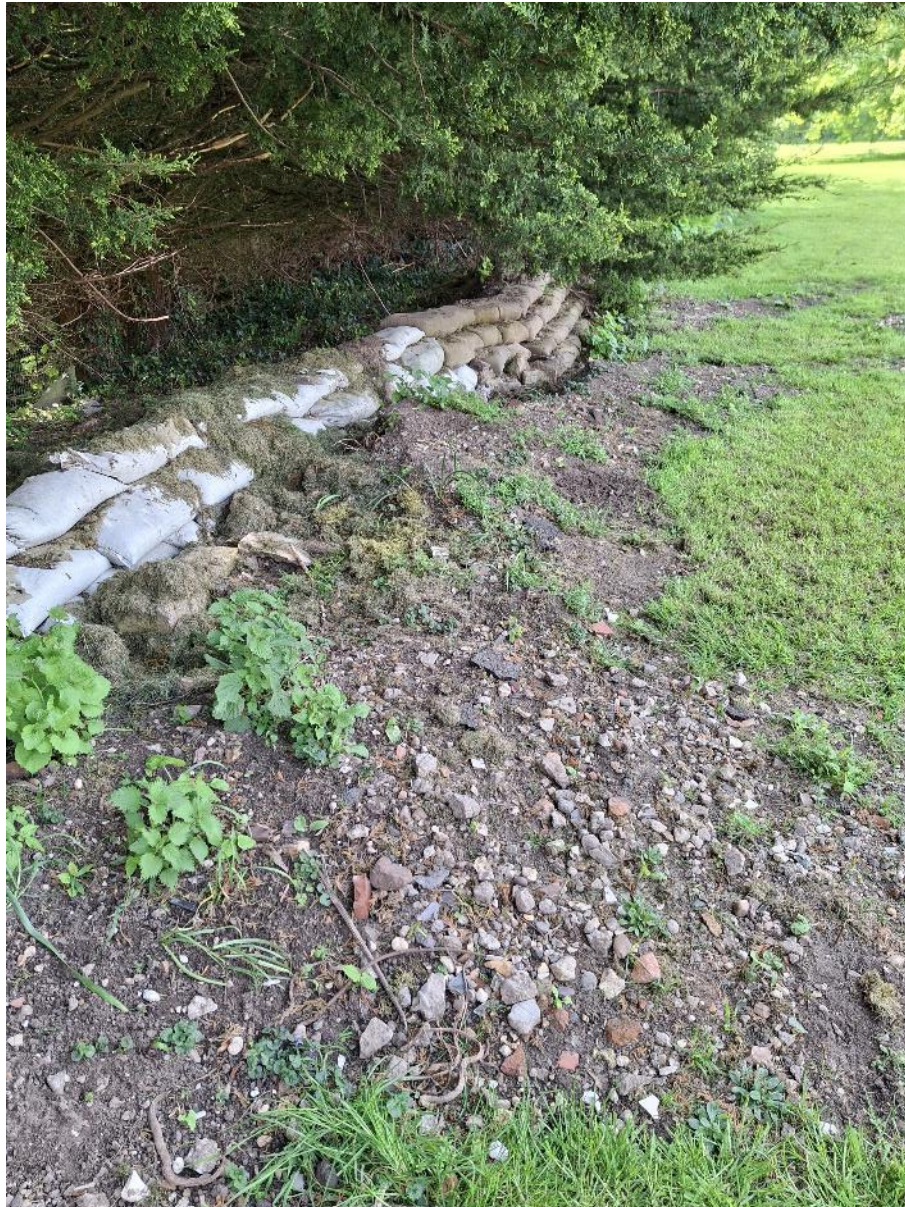
*(Photograph 3.6 – Flood wall comprised of sandbags and concrete by the River Waring within the rear garden at [REDACTED]; facing south-west)*

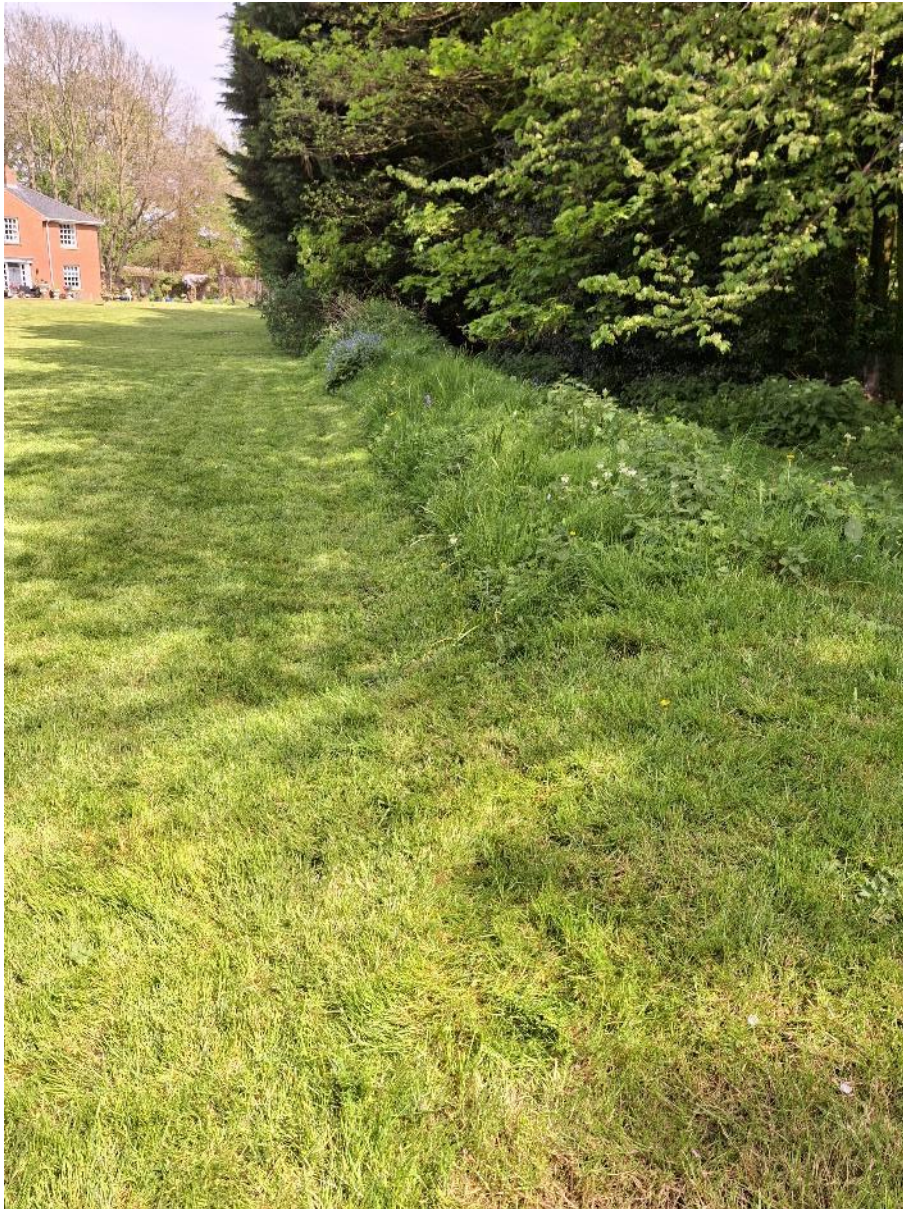
*(Photograph 3.7 – Bund adjacent to the River Waring in the garden at [REDACTED]; facing east)*

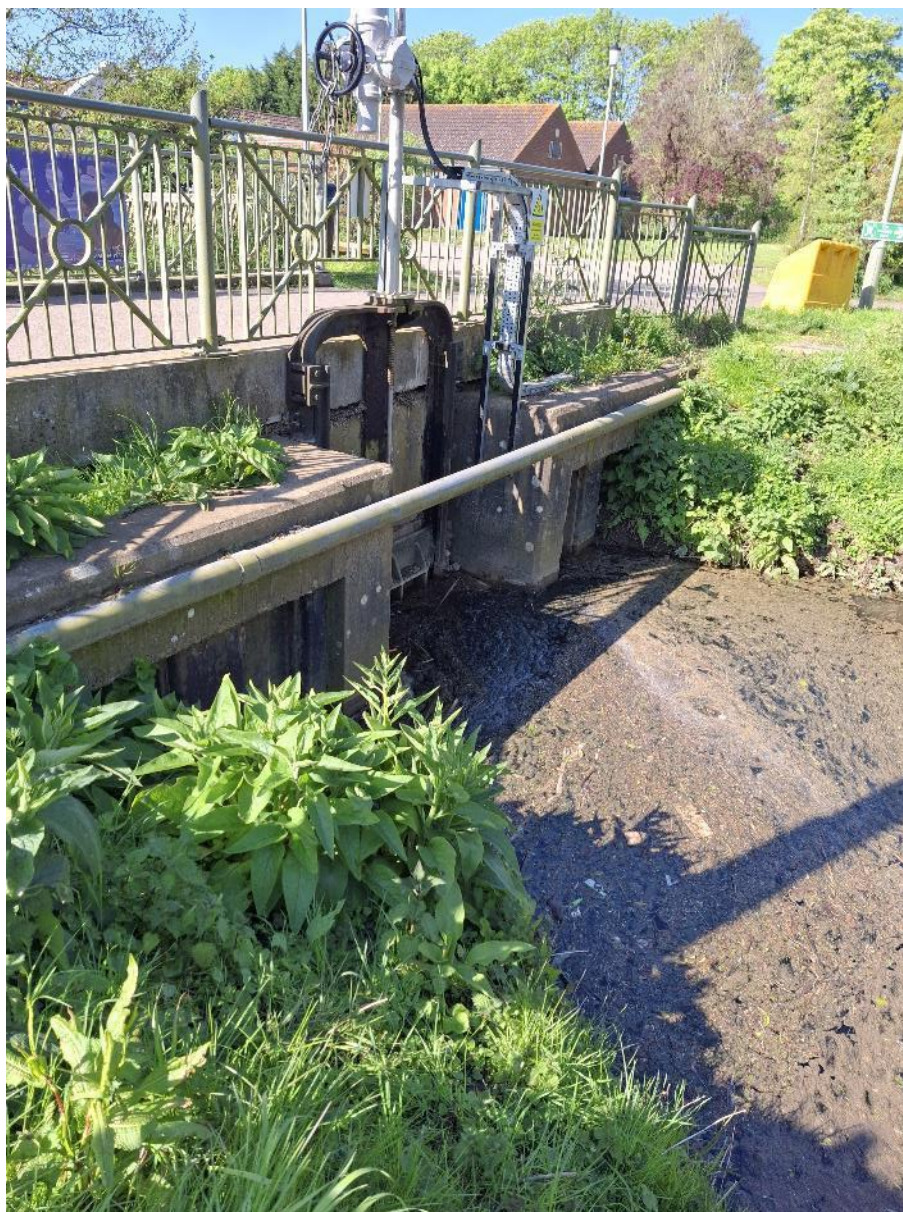
The former channel of the River Bain (the Old River Bain) is located off the River Waring. A sluice gate is present at the confluence between the River Waring and Old River Bain, known as the Swimming Baths Sluice (Photograph 6.1 in Appendix 20); its operation under normal conditions and during Storm Babet is discussed further within Sections 2.4.2 and 3.4.2, respectively. The Swimming Baths Sluice is typically left open by 50mm to control the flows down the Old River Bain.

*(Photograph 6.1 – Swimming Baths Sluice over the Old River Bain, with Horncastle Swimming Pool & Lifestyle Fitness Suite to the rear; facing south-west)*

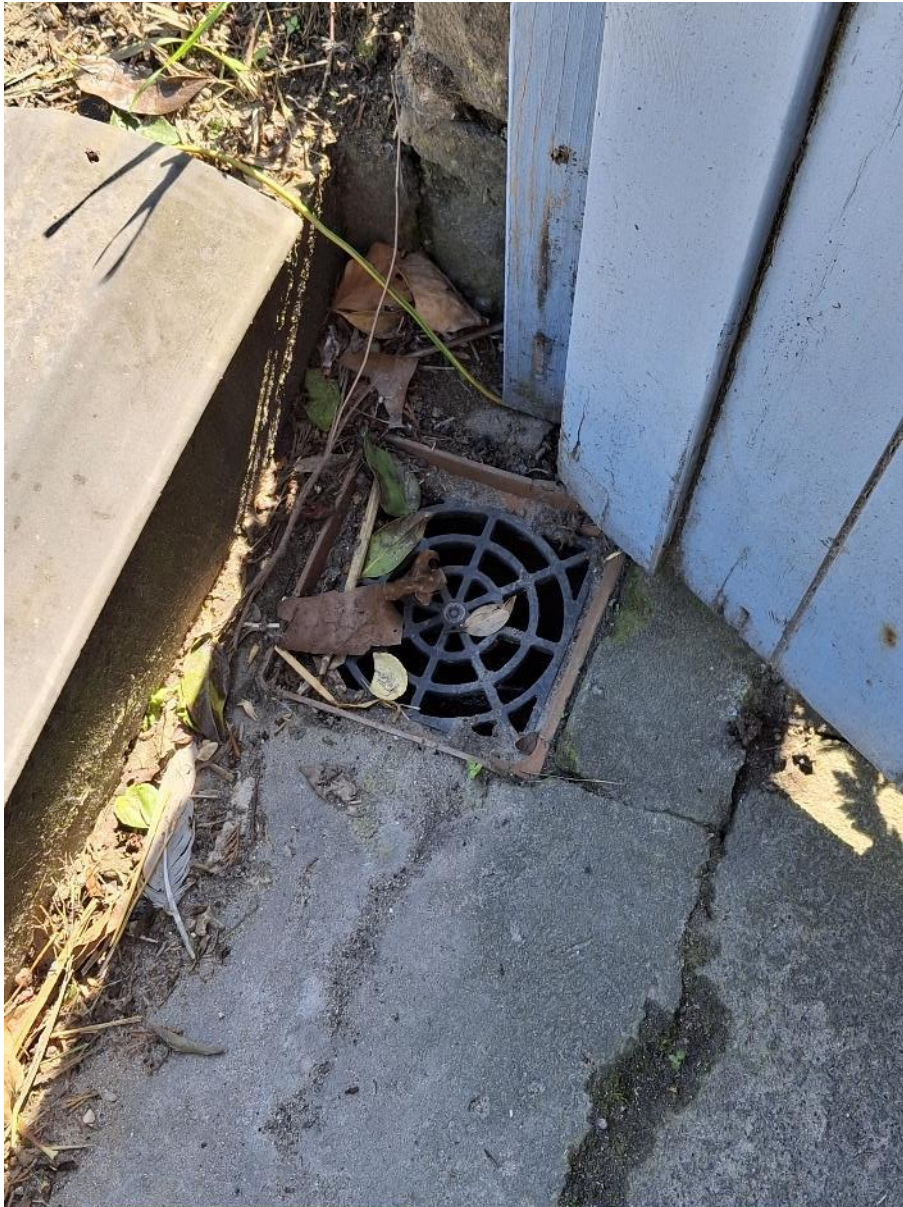
*(Photograph 7.3 – Gully at the front door of [REDACTED])*

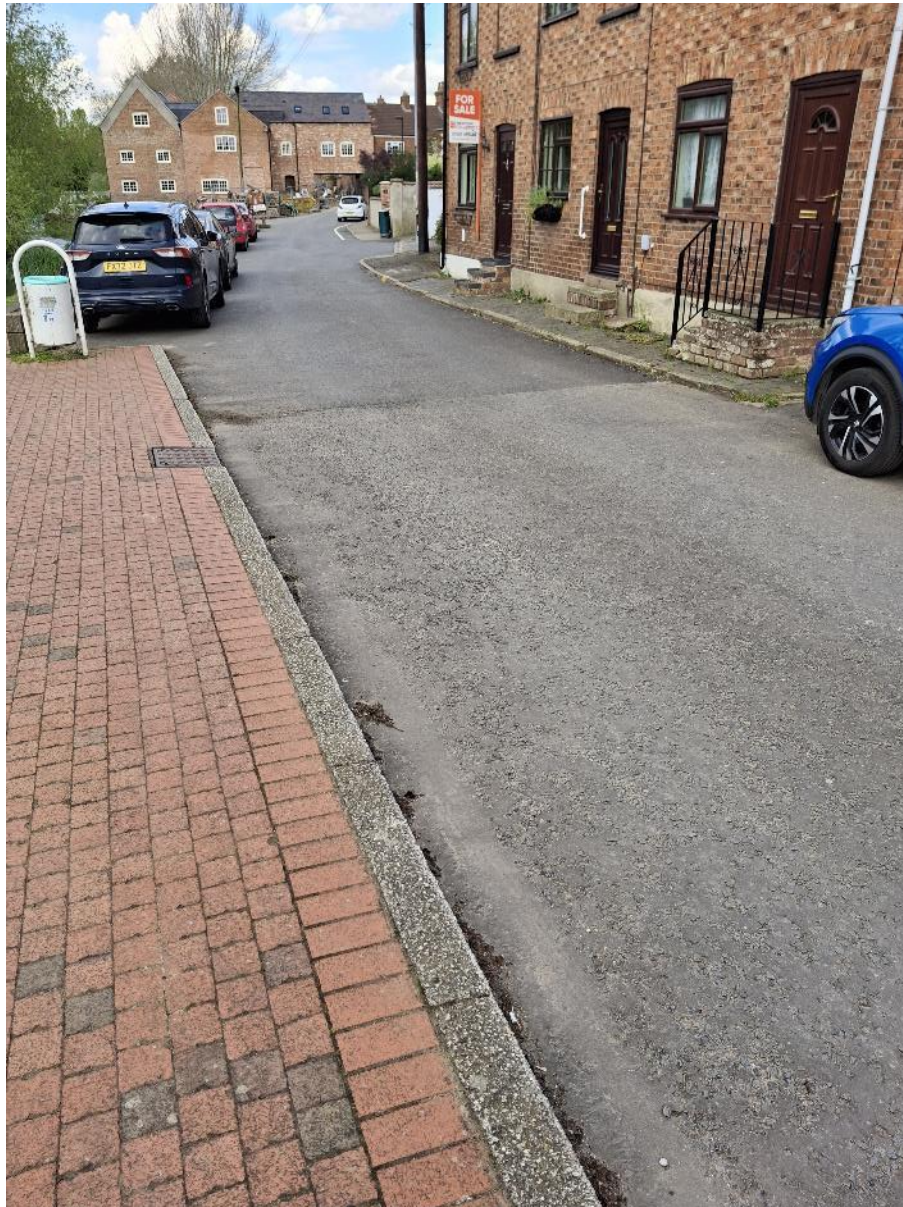
The resident at [REDACTED] confirmed that flood waters did not enter the property, although flood waters were present in the highway. From the Site visit, this may be attributed to the raised threshold levels of the property (Photograph 10.1 in Appendix 20).

*(Photograph 10.1 – Watermill Road; facing north-east)*

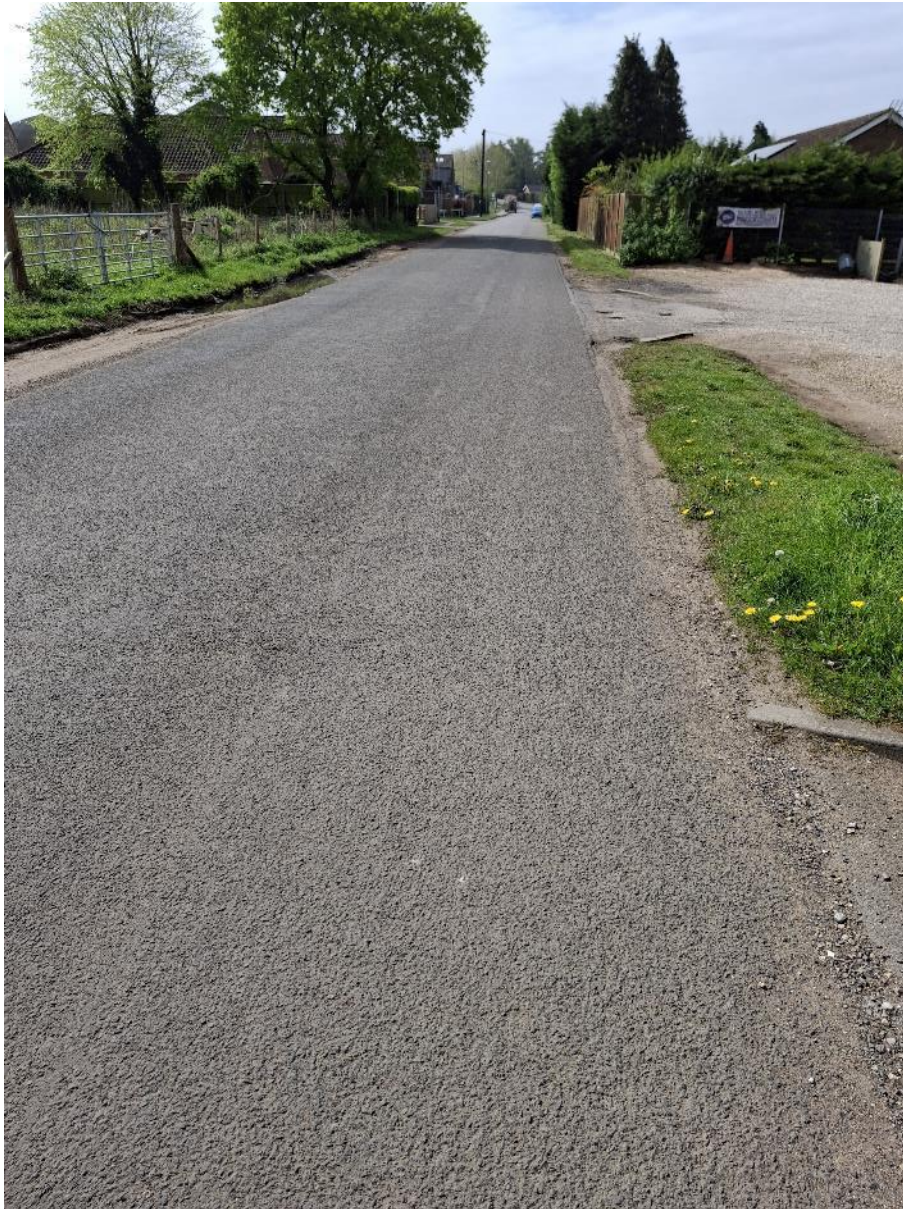
*(Photograph 12.3 – Hemingby Lane, as viewed from the entrance to the [REDACTED] ; facing south)*

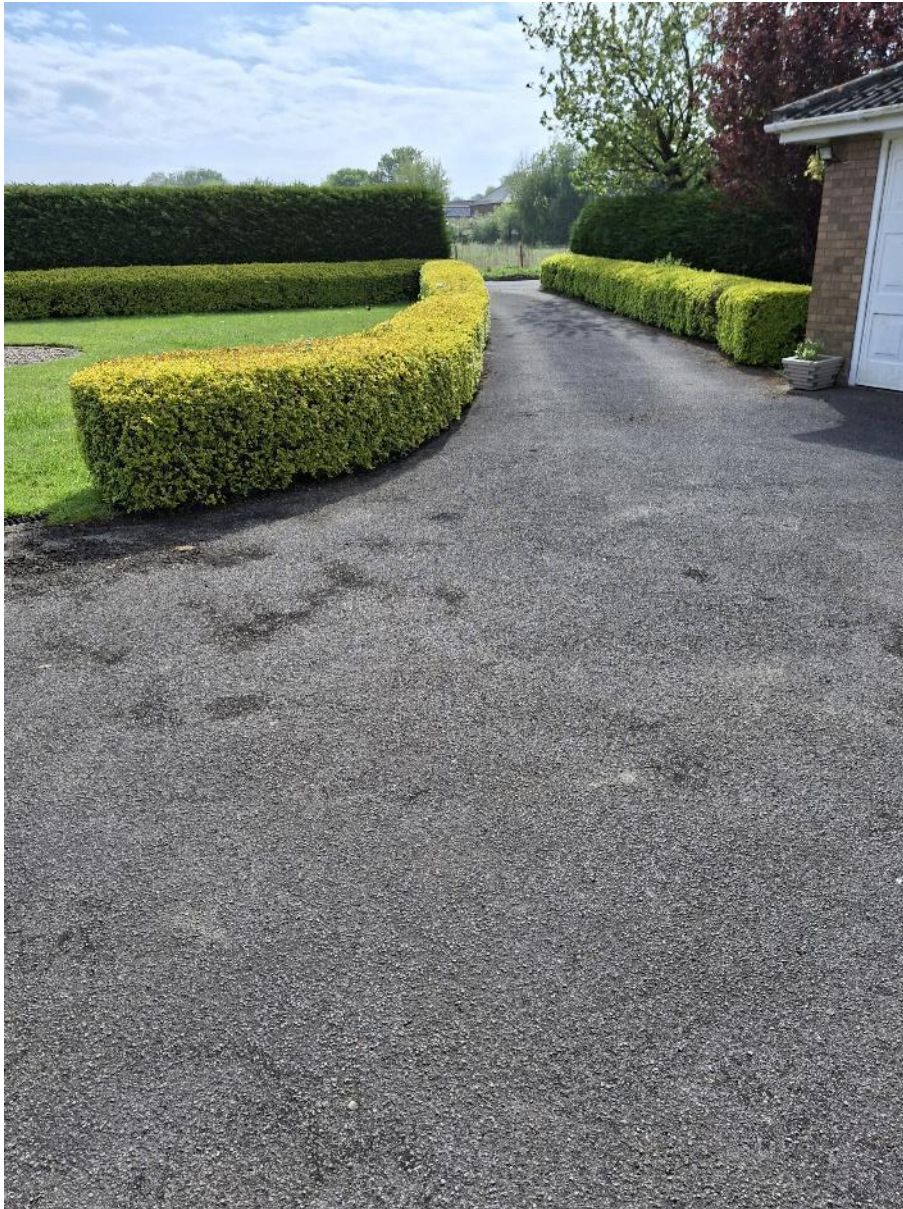
*(Photograph 12.4 – Entrance to [REDACTED]; facing south-east)*

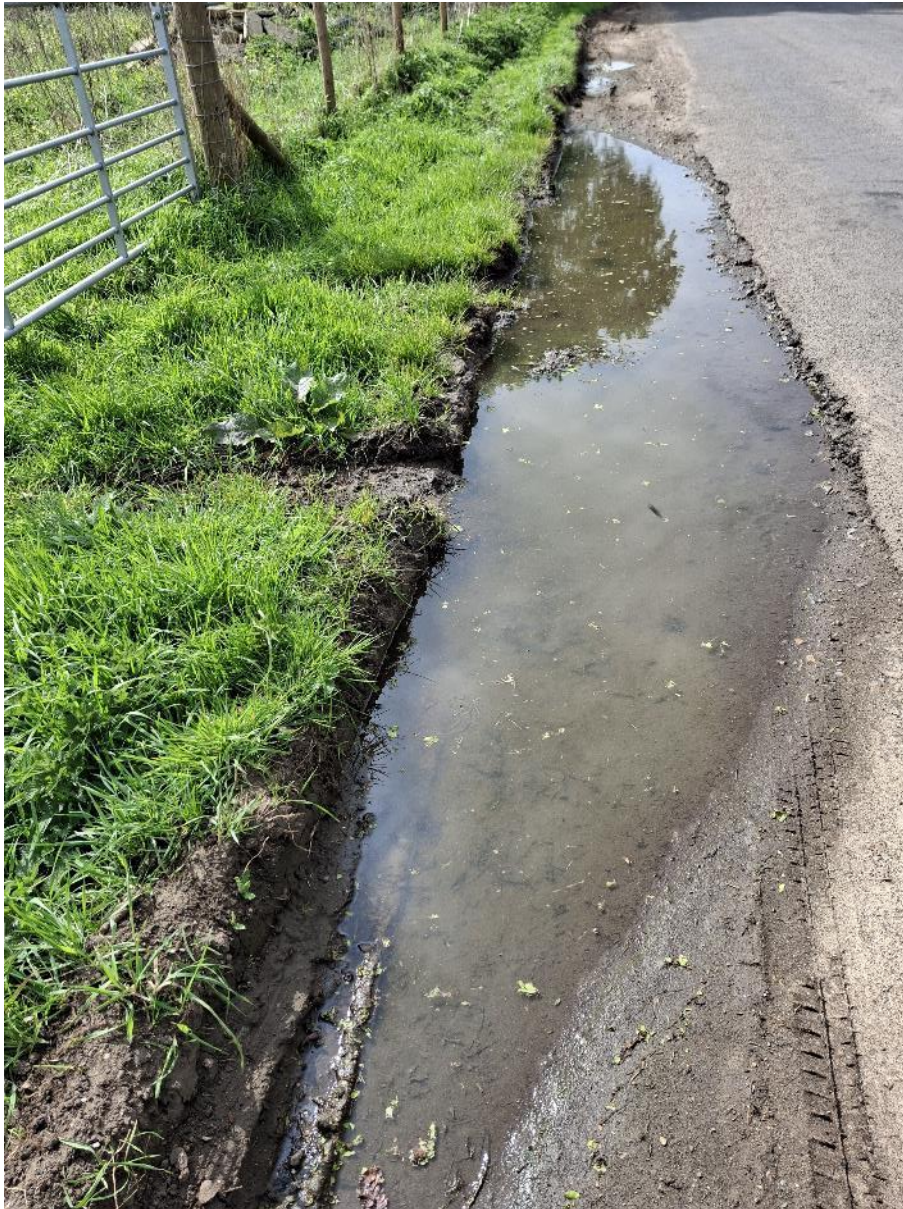
During the Site visit, ponding of surface water was observed on Hemingby Lane, opposite the properties (Photograph 12.5 in Appendix 20).

*(Photograph 12.5 – Ponding on Hemingby Lane, [REDACTED]; facing south)*

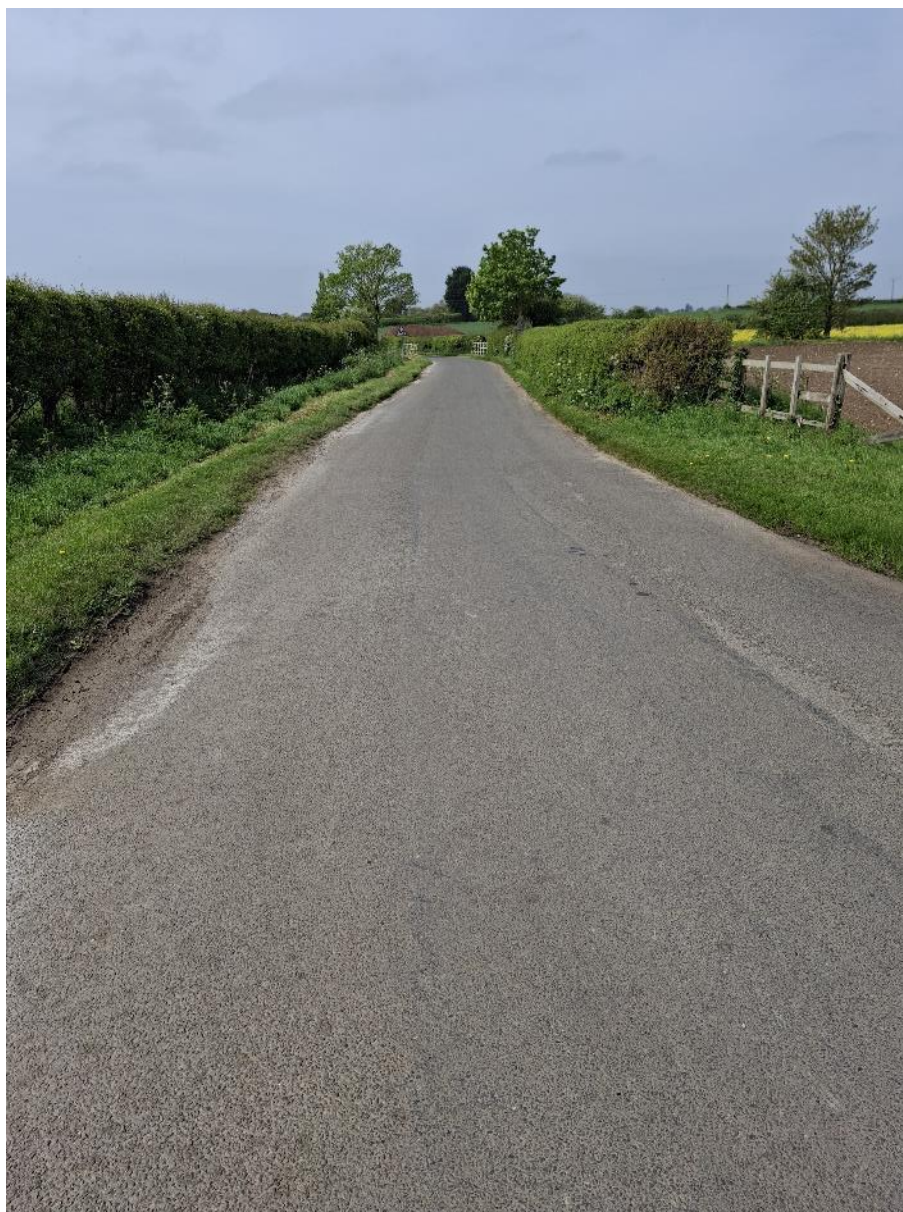
*(Photograph 13.1 – low Toynton Road at the point of marked road closure; facing south-west)*

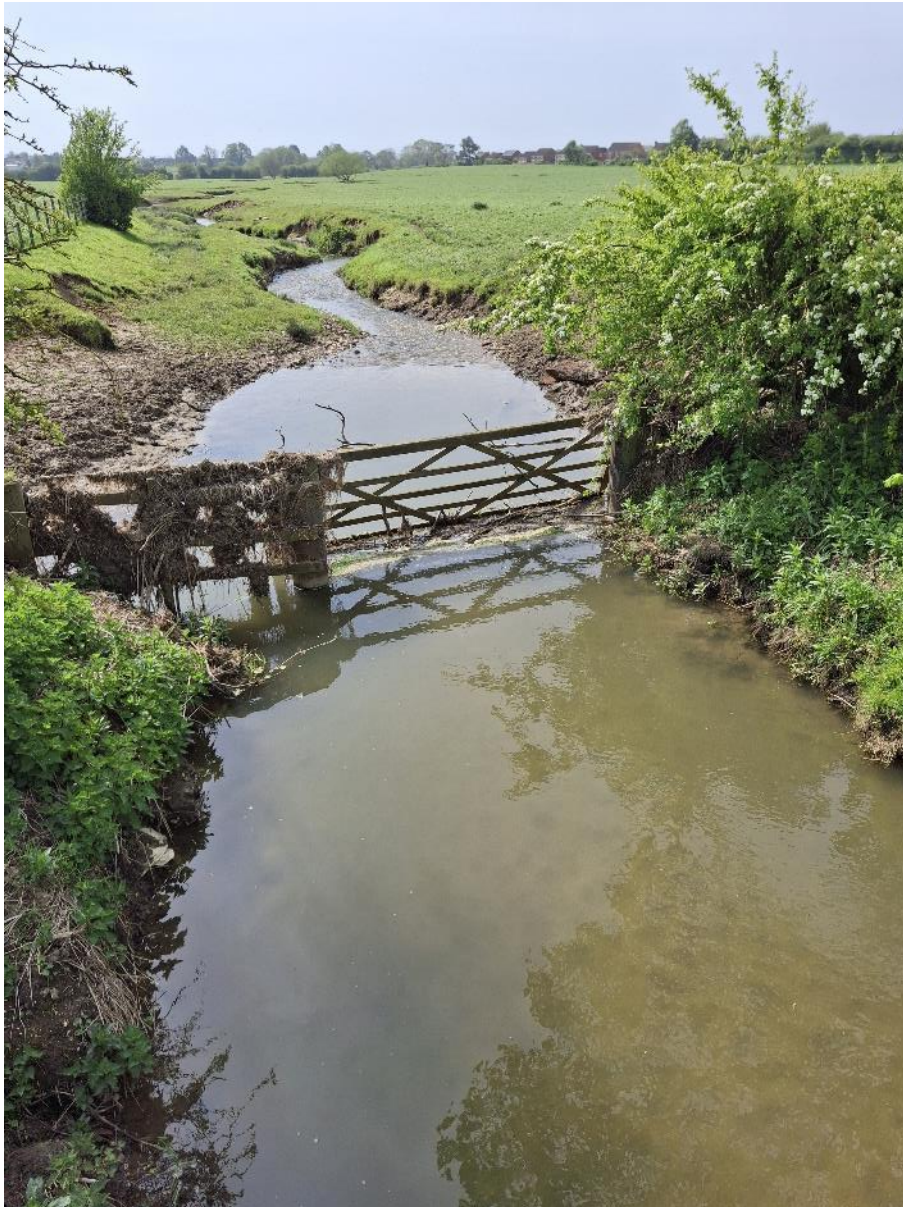
*(Photograph 13.2 – River Waring as it crosses low Toynton Road; facing south)*

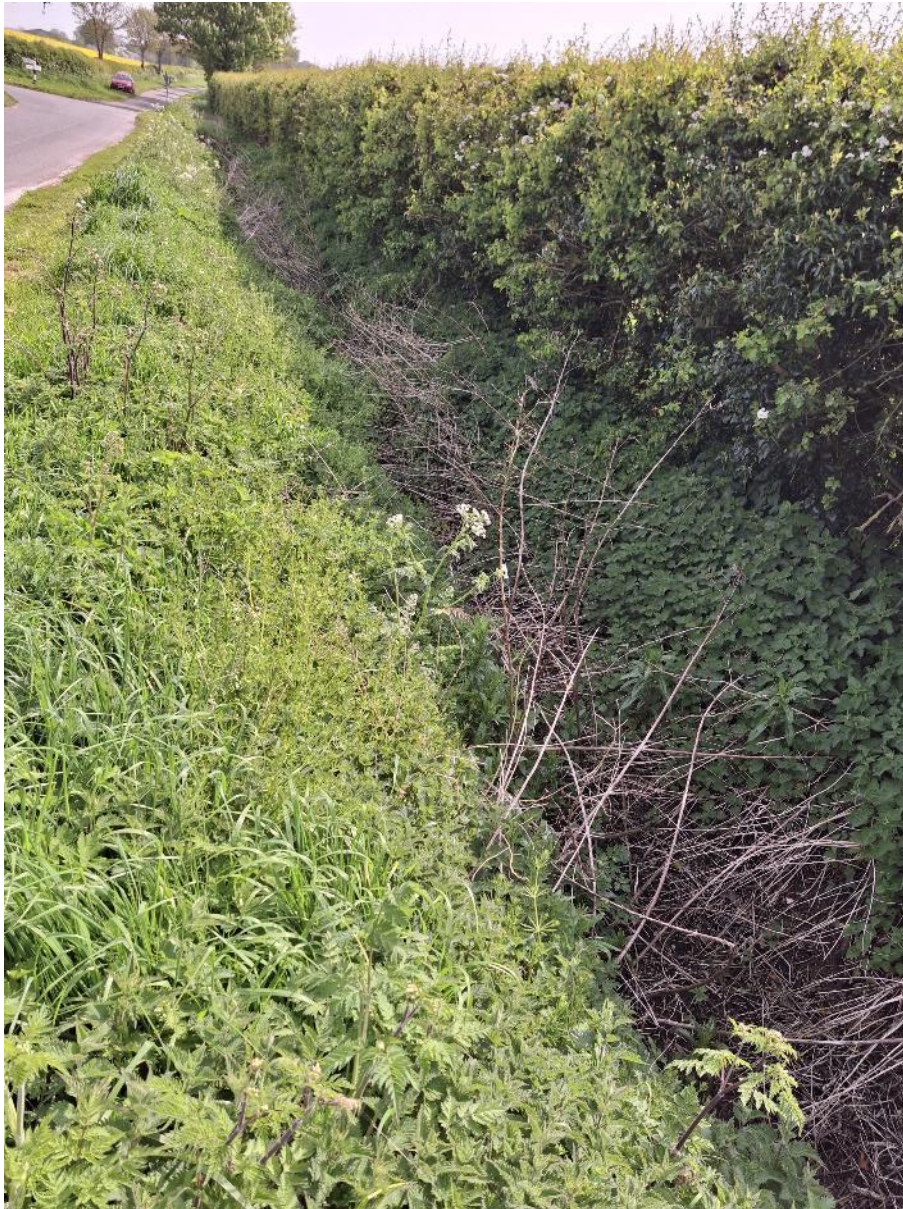
*(Photograph 13.3 – Drainage ditch adjacent to low Toynton Road; facing north-east)*

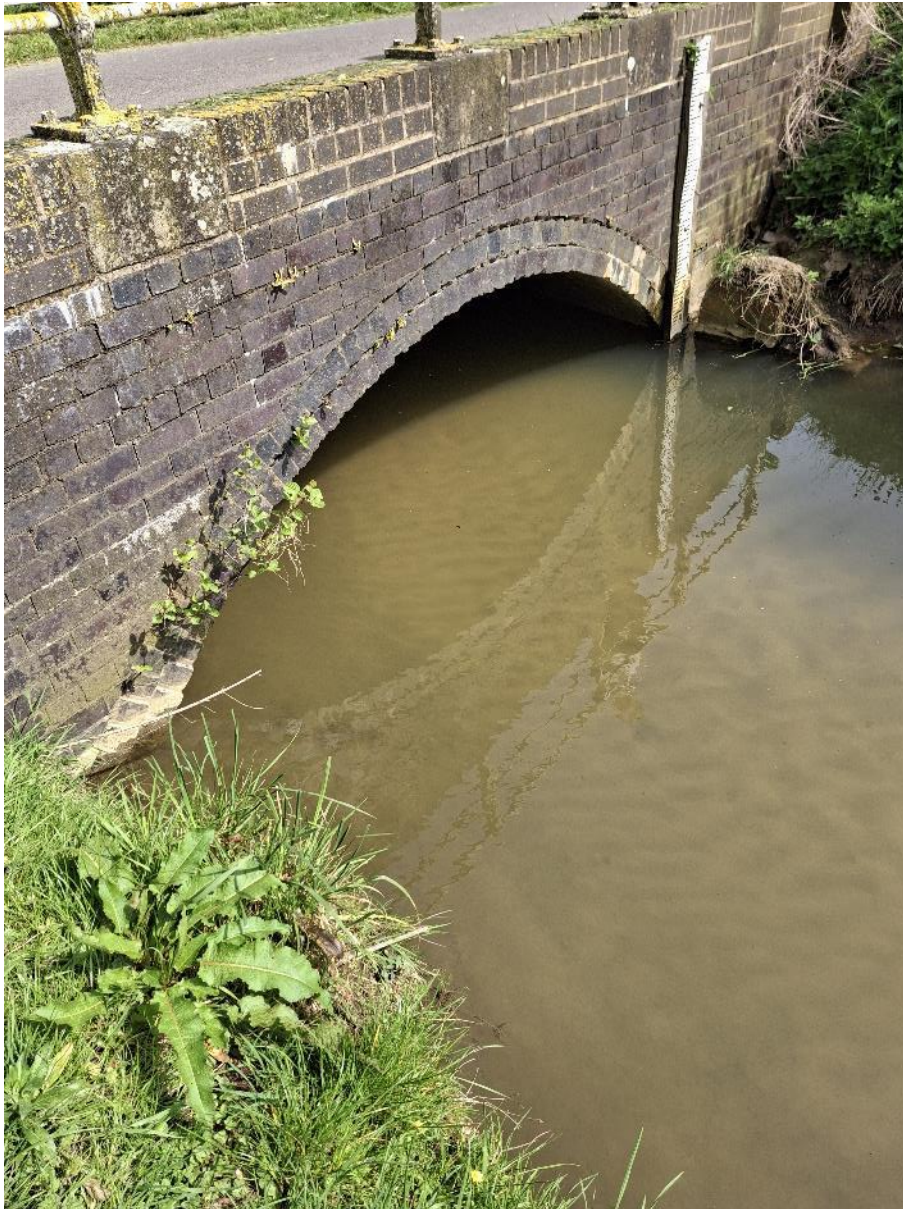
During the Site visit on 01 May 2024, the River Waring was observed to have a shallow channel in this area. low Toynton Road crosses the watercourse using a bridge which was observed to have a relatively low soffit (Photograph 13.4 in Appendix 20). It is therefore possible that the capacity of the channel was exceeded due to extreme flows down the river, with the bridge potentially contributing to a restriction of flows.

*(Photograph 13.4 – Bridge over River Waring on low Toynton Road)*

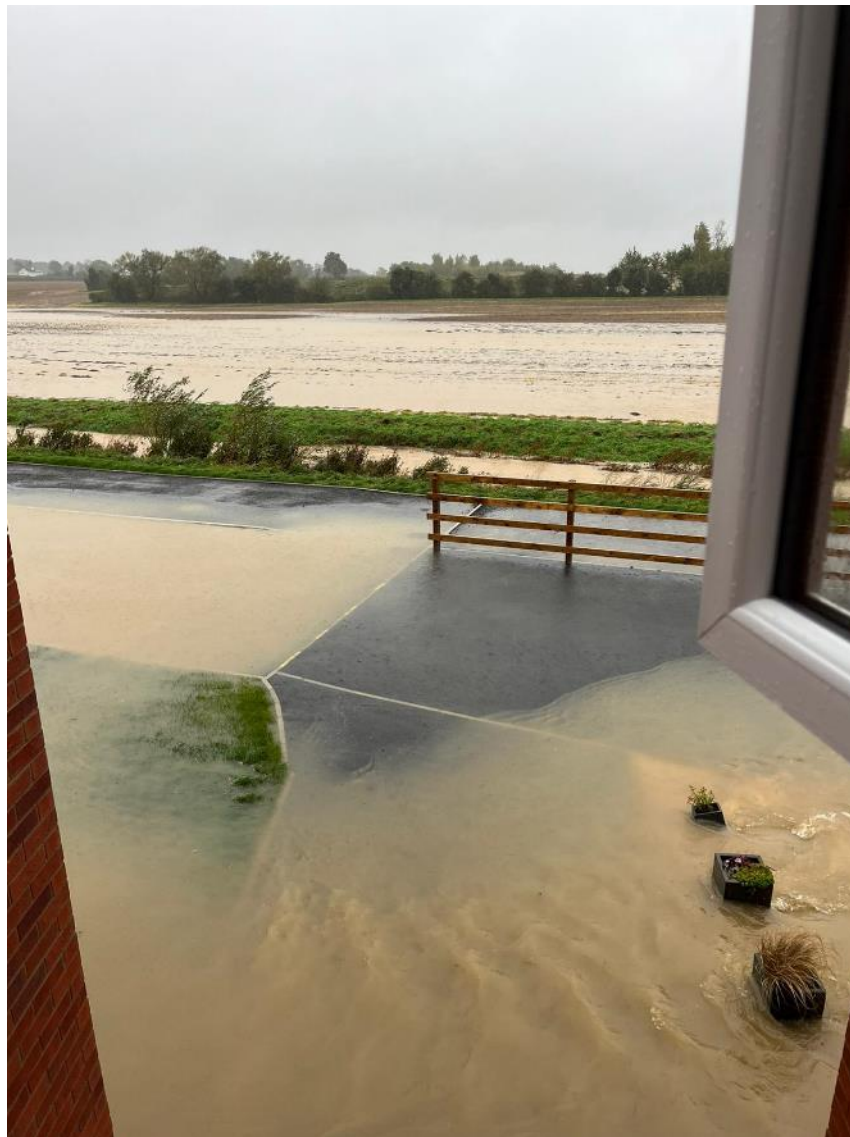
*(Photograph 1.5 – Flooding to the south of [REDACTED] at around 12:30; facing south)*

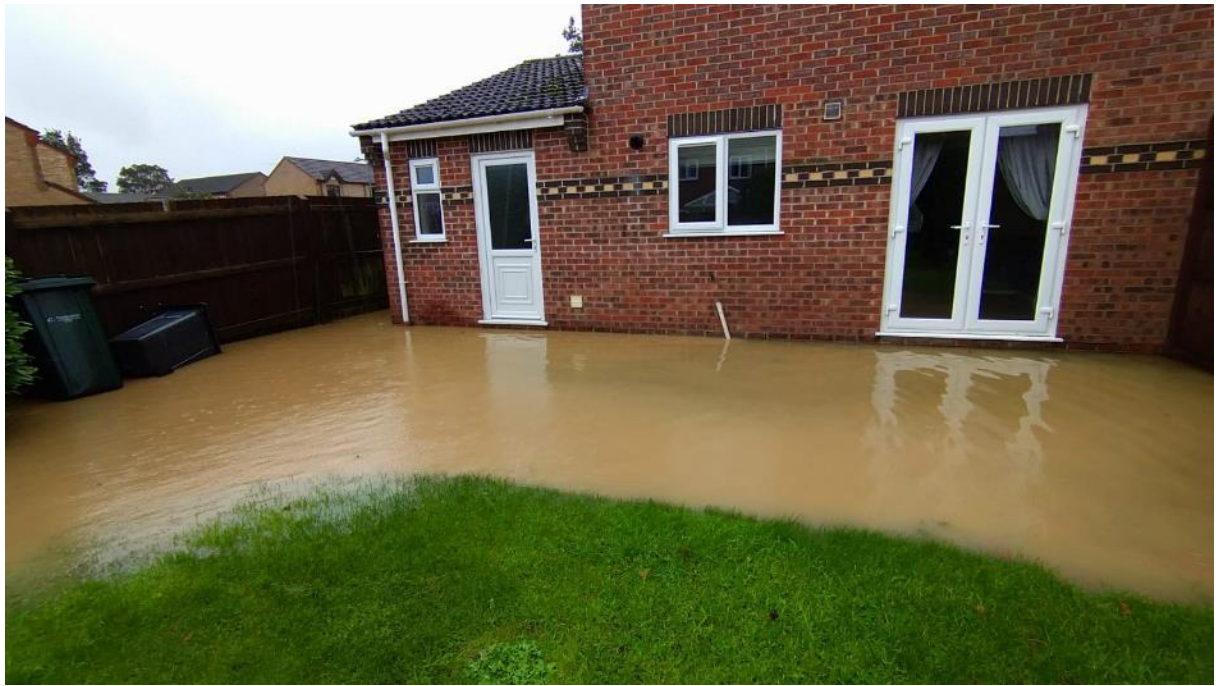
*(Photograph 2.18 – Flood waters in the rear garden at [REDACTED])*

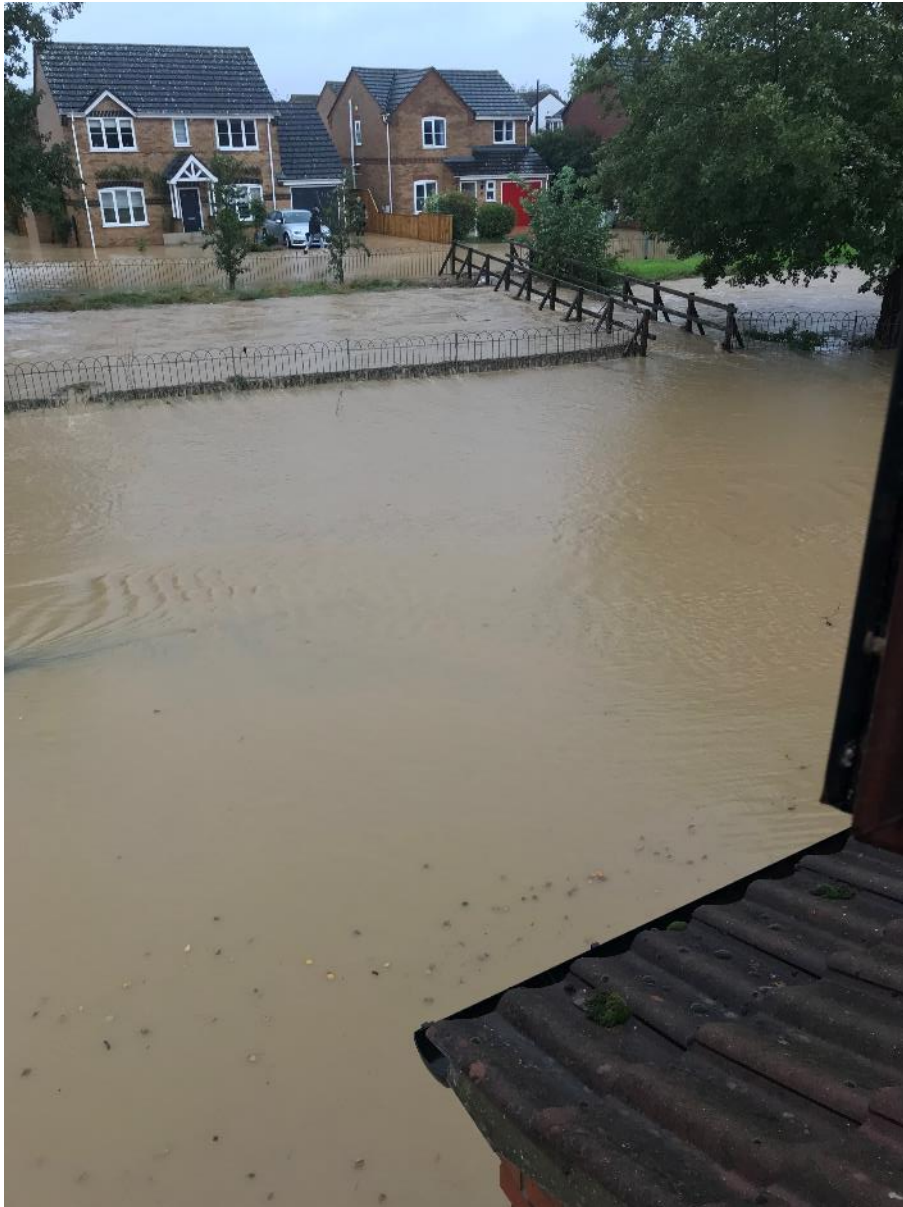
*(Photograph 2.19 – Flood waters to the front of [REDACTED], with the channel of the Thunker Drain shown and Lodington Court beyond; facing south)*
